<b>FDI</b>	<b>ENGINEERING CHANGE ORDER</b>		<b>ECO NO: 09-012</b>
			<b>Page 1 of 3</b>
<b>TITLE</b>	<b>DWG NO.</b>	<b>CURRENT REV</b>	<b>NEW REV</b>
LCD Carrier 3-5		1.0	1.1

<b>FDI</b>	<b>ENGINEERING CHANGE ORDER</b>		<b>ECO NO: 09-013</b>
			<b>Page 1 of 4</b>
<b>TITLE</b>	<b>DWG NO.</b>	<b>CURRENT REV</b>	<b>NEW REV</b>
LCD Carrier 3-5		1.1	1.2

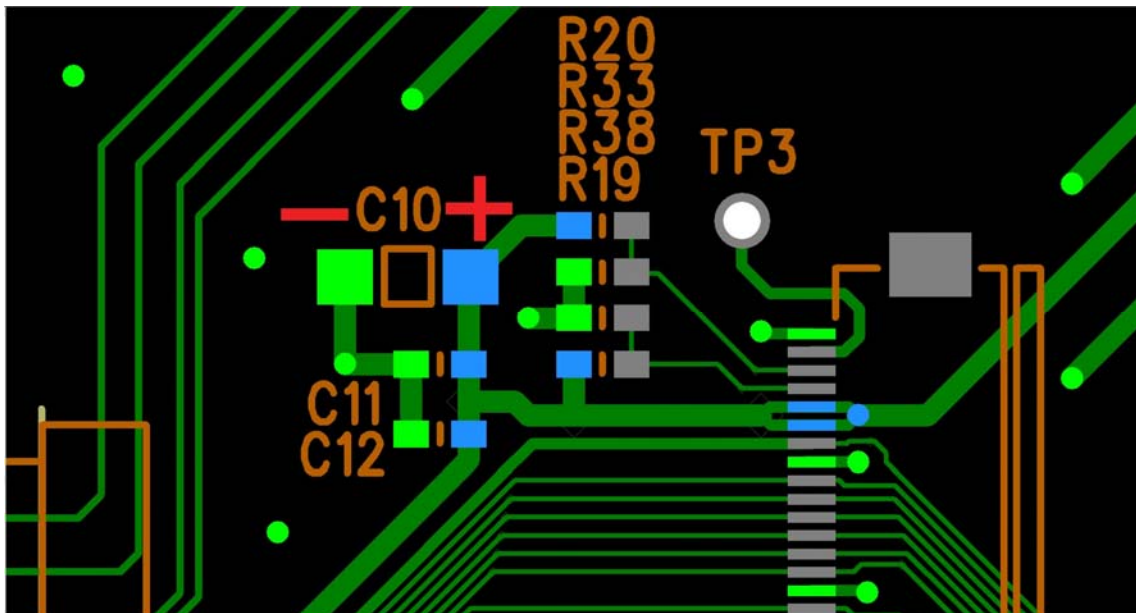
As the LCD Carrier 3-5 REV 1 was sent to production, it was discovered that the Bill Of Materials calls for Tantalum capacitors at C10, C31, C34. However, there are no polarity markings on the REV 1 PCB.

Figure 1 C10 Polarity

1. The BOM will be corrected to include ceramic caps for future builds of REV 1 and for future hardware revisions.
2. To avoid production delays we will use the Tantalum caps on the first production lot of LCDC 3-5 REV1. Diagrams to indicate cap polarity are provided in Figures 1 thru 3.

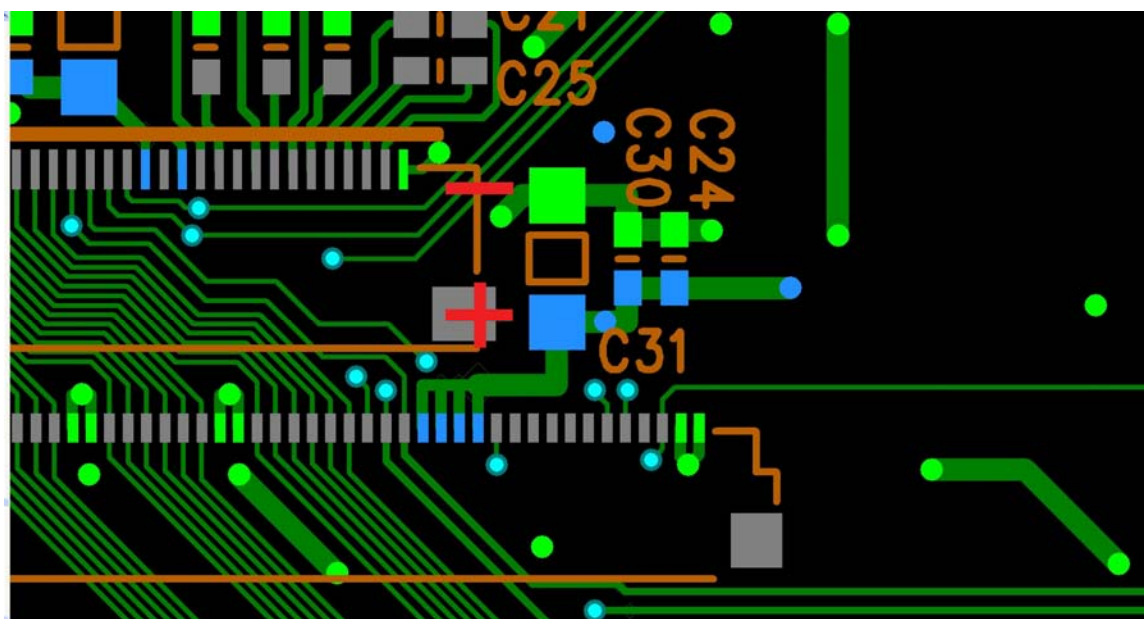
Figure 2 C31 Polarity

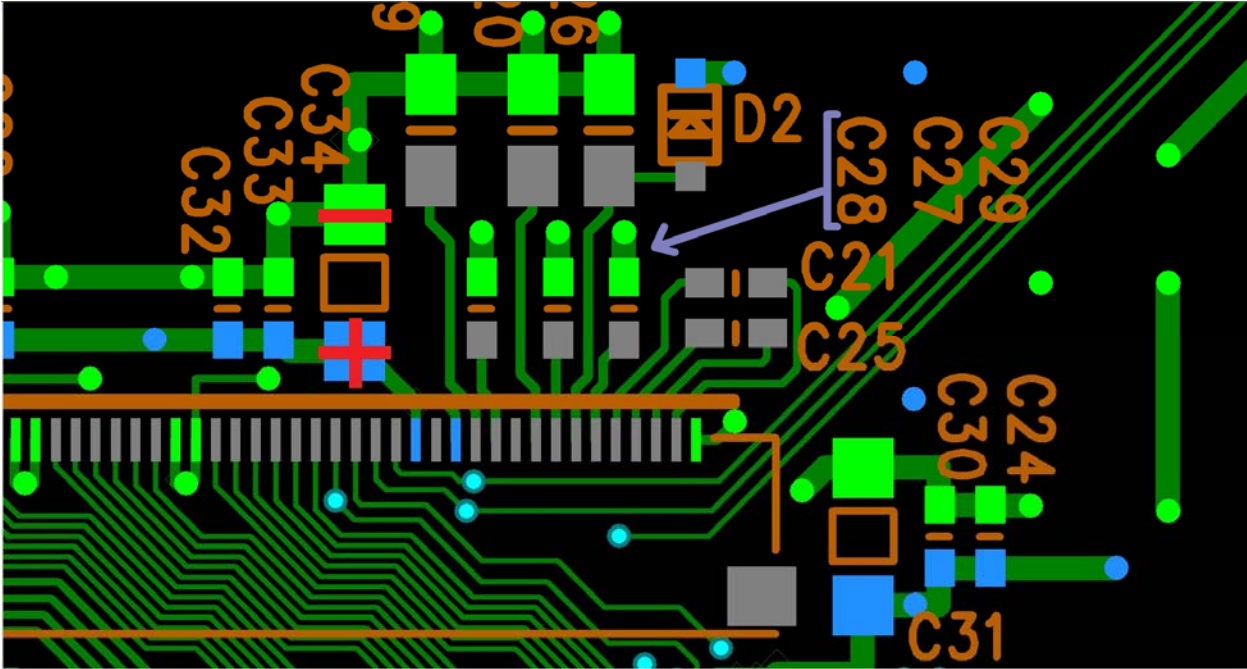
Figure 3 C34 Polarity

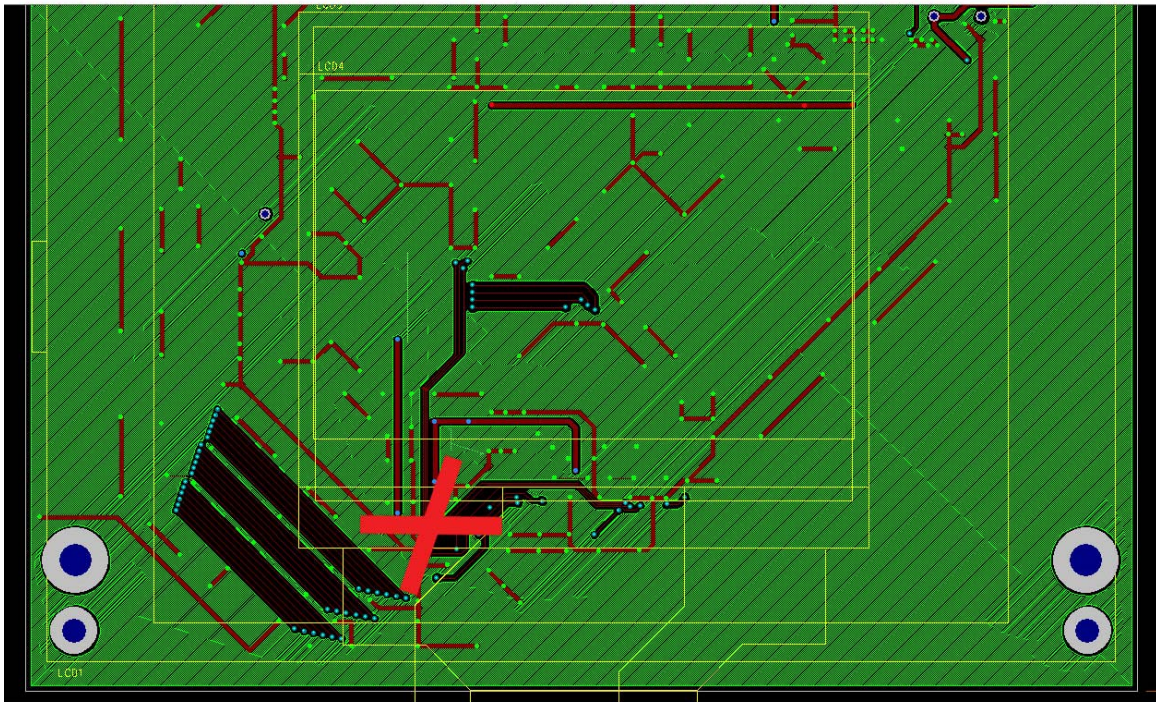
Software driver development for the 3.5" Okaya also uncovered a schematic error on the SPI bus. Although, SPI is properly terminated at the LCD and at the main 50-pin connector back to ARM Carrier, an error existed in the connection between the two schematic pages that effectively connected MISO to SDI (Serial Data In) of the LCD. This obviously should have been connected to MOSI.

Figure 1 General Area of Cut (LCDC 3-5 REV1 TOP Side)

1. Cut EXT\_MISO trace between J4.45 and J10.50. The cut is made on the TOP side of the PCB. Figure 1 shows the general area of the cut and Figure 2 shows a detail of the cut.

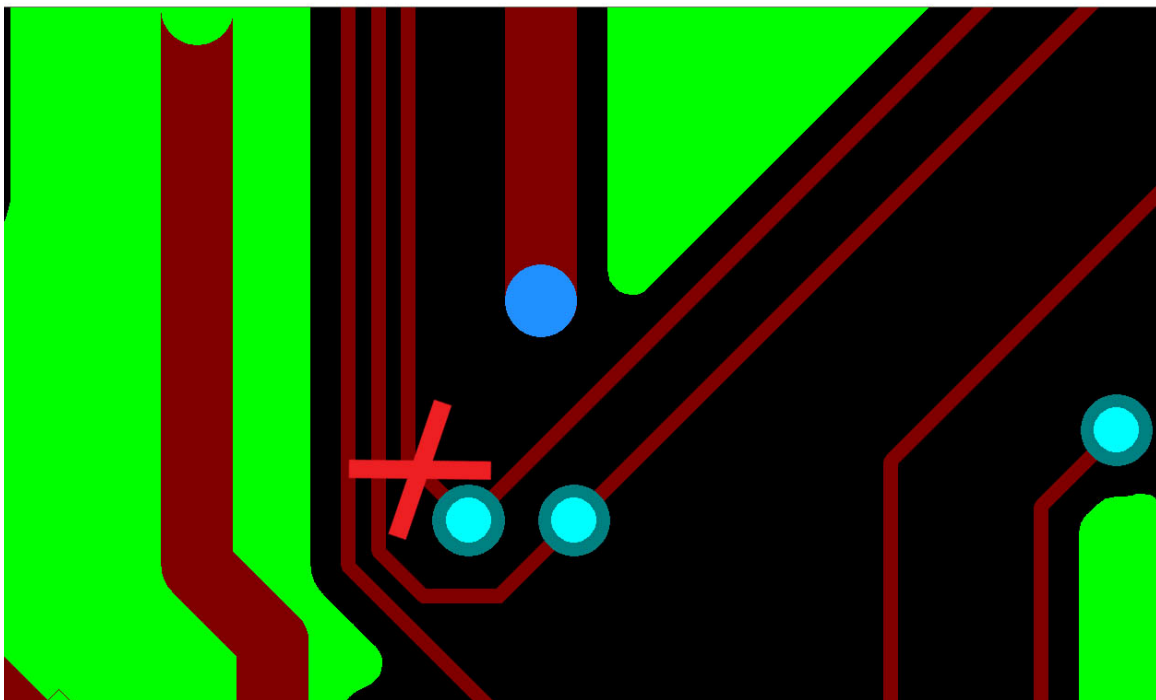
Figure 2 Detail Zoom of Cut (LCDC 3-5 REV1 TOP Side)

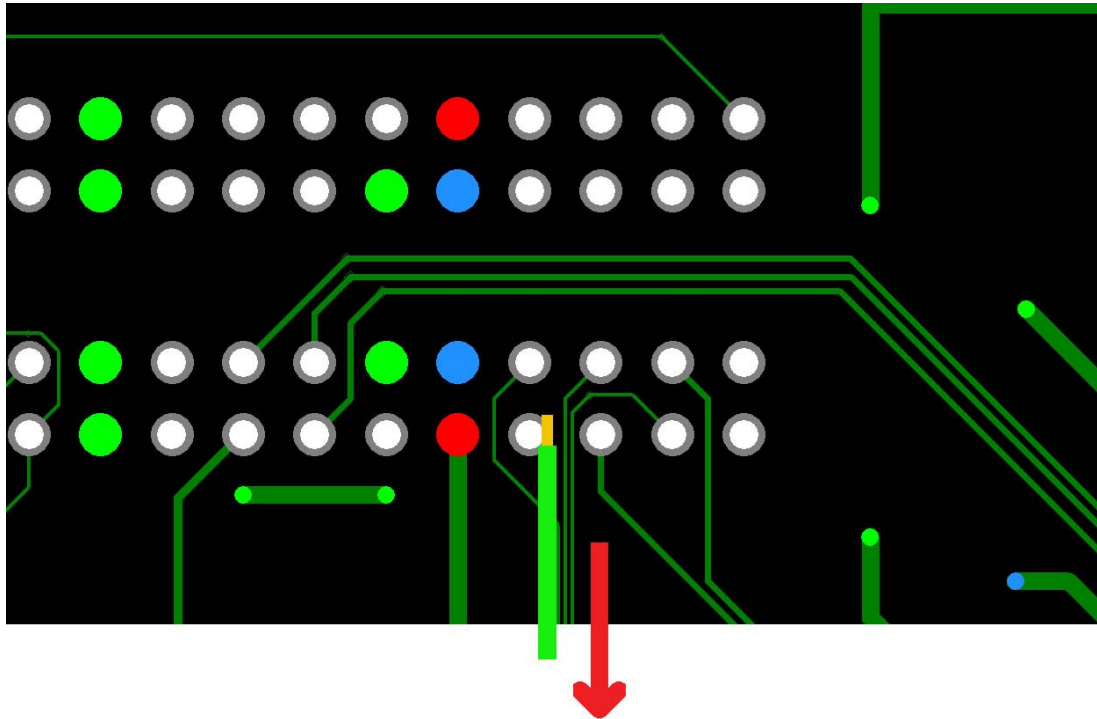
**Figure 3** Rework Wire Connection at J4.44

2. Add a 30 AWG Solid rework wire between J4.44 and J10.50. On the J10 side, you can connect at the adjacent via if it is easier to do so. Figure 3 shows a detail of the connection at J4 and Figure 4 illustrates the connection at J10.

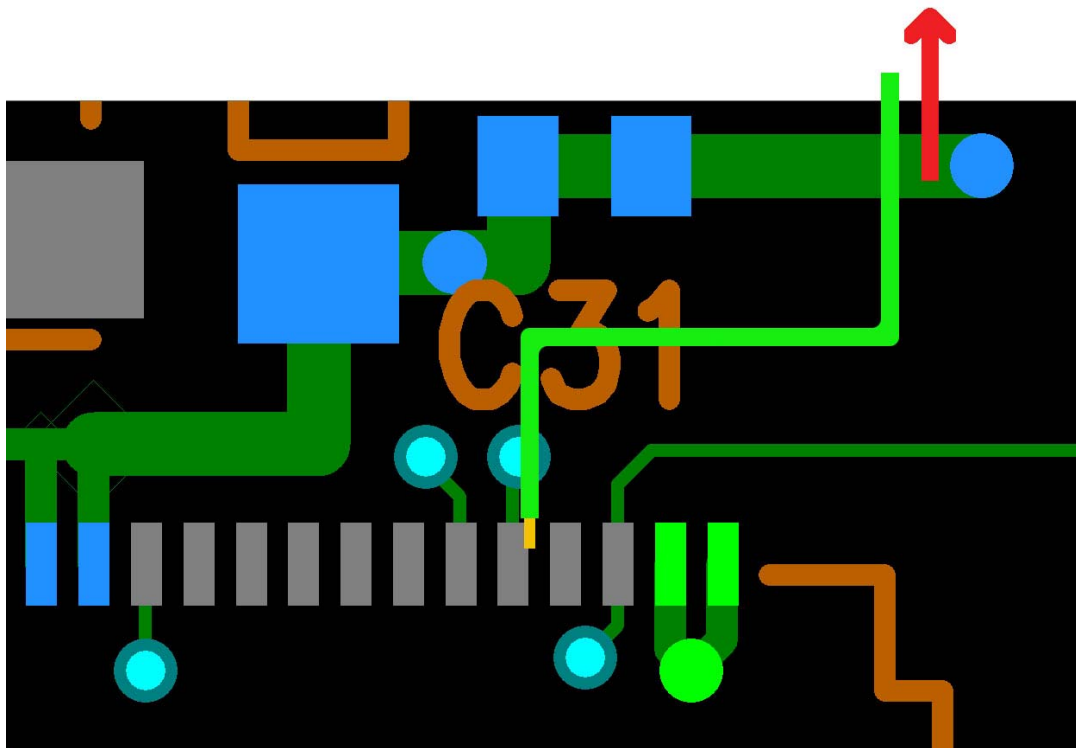
**Figure 4** Rework Wire Connection at J10.50

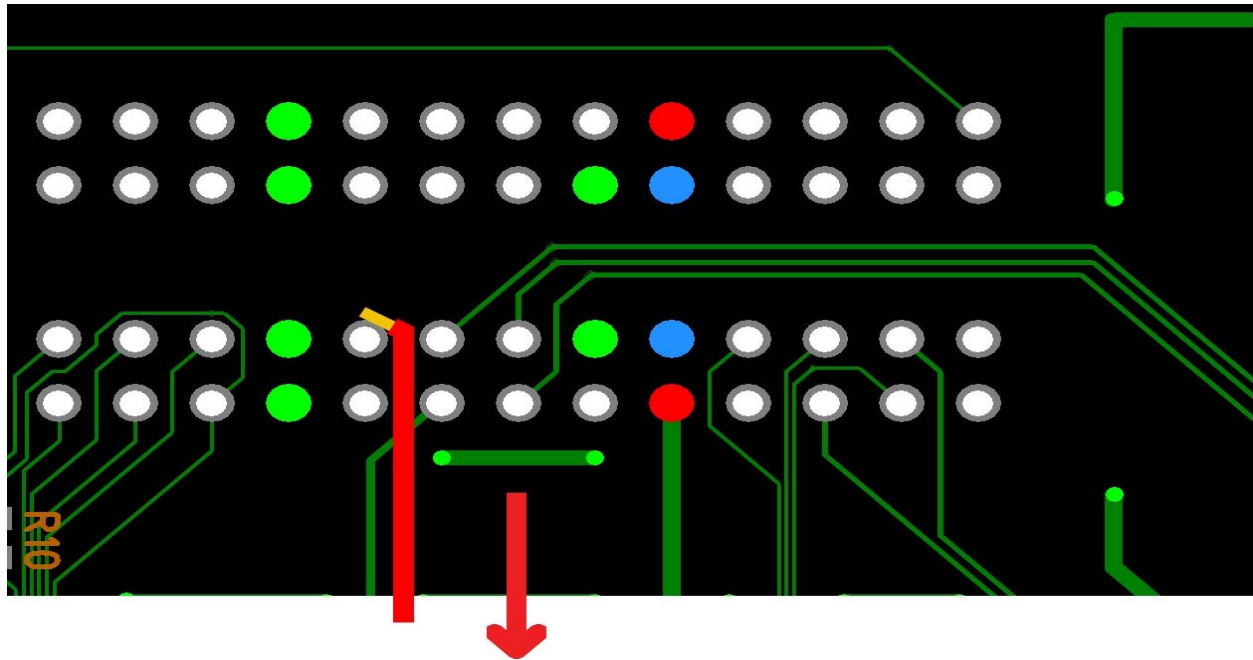
When the initial hardware design was done, it was assumed that an internal pull down would be sufficient termination for the SHUT pin of the Okaya 3.5" LCD, and the pin was left not connected. However, during software driver development, it was discovered that the LCD must see a falling edge on this signal during startup. The LCDPWR signal was selected for this task since its purpose of controlling backlight power was obsoleted on the LCDC 3-5 which uses PWM for backlight control.

Figure 5 Rework Wire Connection at J4.33

3. Add a 30 AWG Solid rework wire between J4.33 and J10.48. Figure 5 shows a detail of the connection at J4 and Figure 6 illustrates the connection at J10.

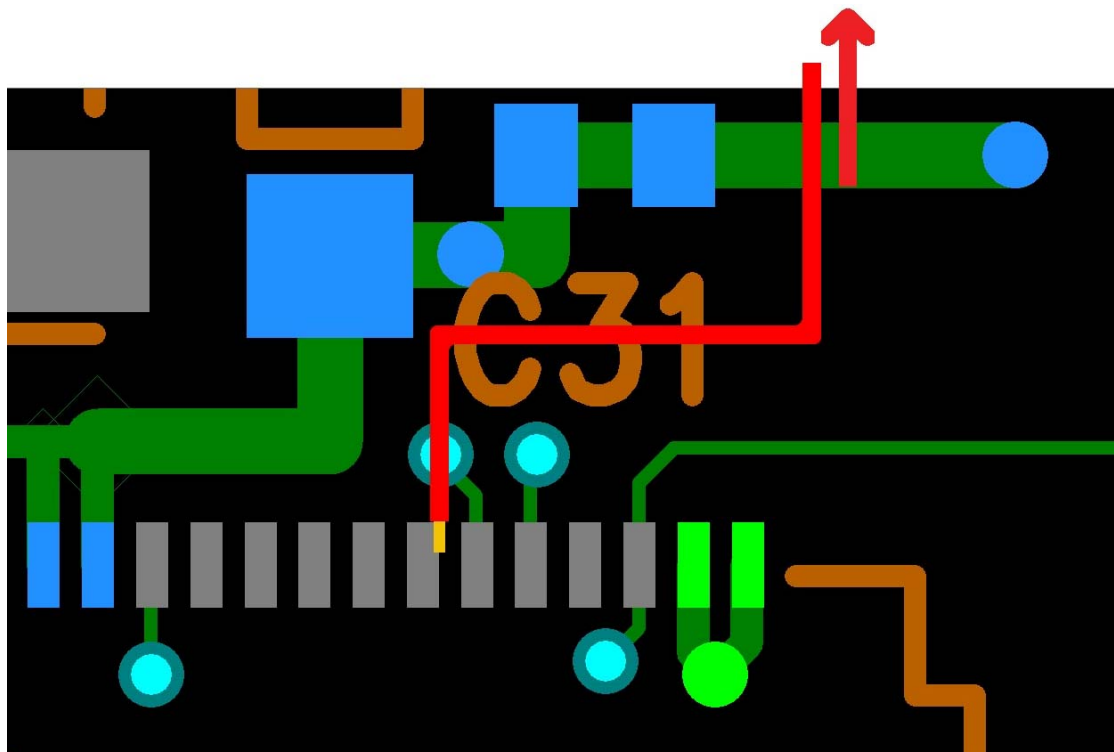
Figure 6 Rework Wire Connection at J10.48
