FDI	ENGINEERING CHANGE ORDER		ECO NO: 09-000.1
			Page 1 of 1
TITLE	DWG NO.	CURRENT REV	NEW REV
ARM7DIMM LPC2478	ARM7DIMM	2.0	2.1

FDI	ENGINEERING CHANGE ORDER		ECO NO: 09-000.2
			Page 1 of 1
TITLE	DWG NO.	CURRENT REV	NEW REV
ARM7DIMM LPC2478	ARM7DIMM	2.1	2.2

FDI	ENGINEERING CHANGE ORDER		ECO NO: 09-002
			Page 1 of 1
TITLE	DWG NO.	CURRENT REV	NEW REV
ARM7DIMM LPC2478	ARM7DIMM	2.2	2.3

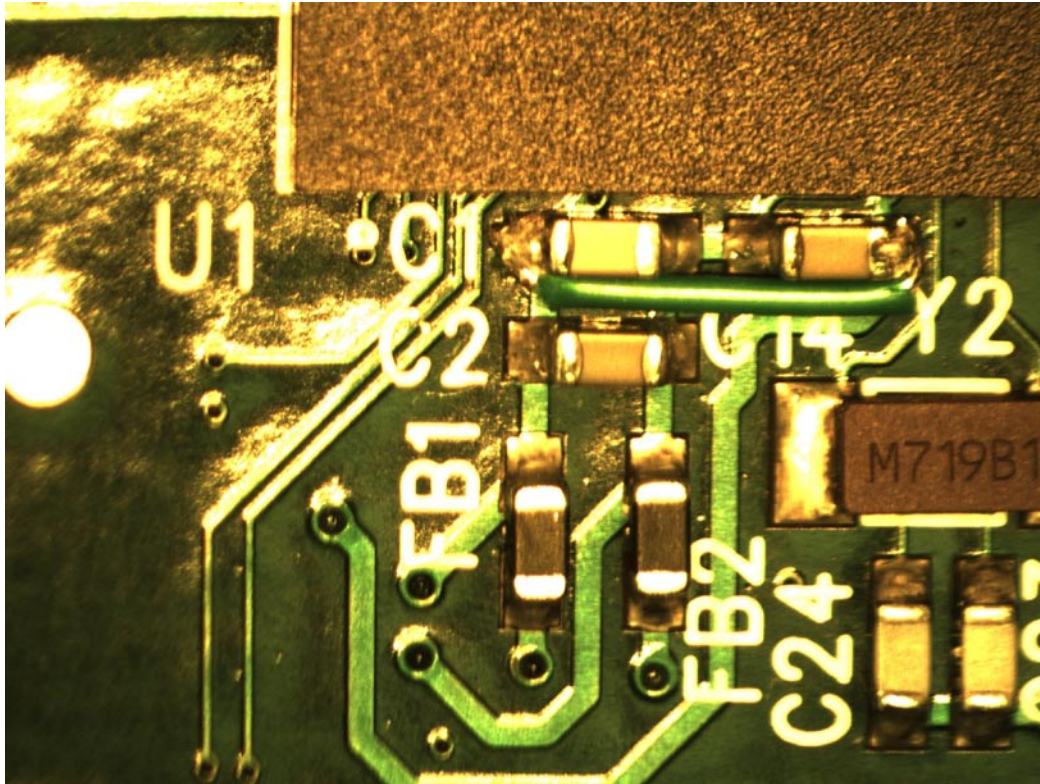
The ADC Vref pin is not connected to a source, hence the ADCs do not function.

1. Add wire from right side of C14 to left side of C1 as shown below;

Reason for change: 1. Correction for Vref connectivity		Disposition/Effectively	
		Use as is	
		Rework to ECO	X
		Scrap & Rebuild	
		Record Change Only	
Prepared by:	M. Hall	Date:	03/27/09
Approved by:		Date:	
Approved by:		Date:	
Approved by:		Date:

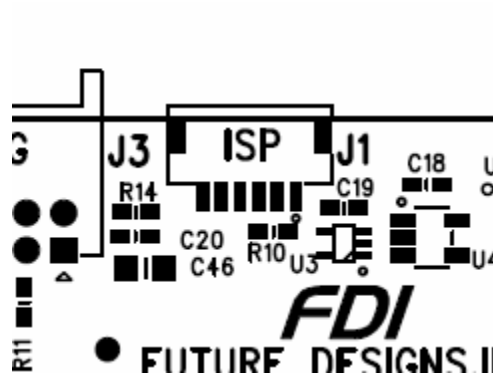
The ISP connector is needed for functional test and ease of customer reprogramming of the CPU

1. Load J1 with FDI PN: J500030 (JST SM06B-SHLS-TF)

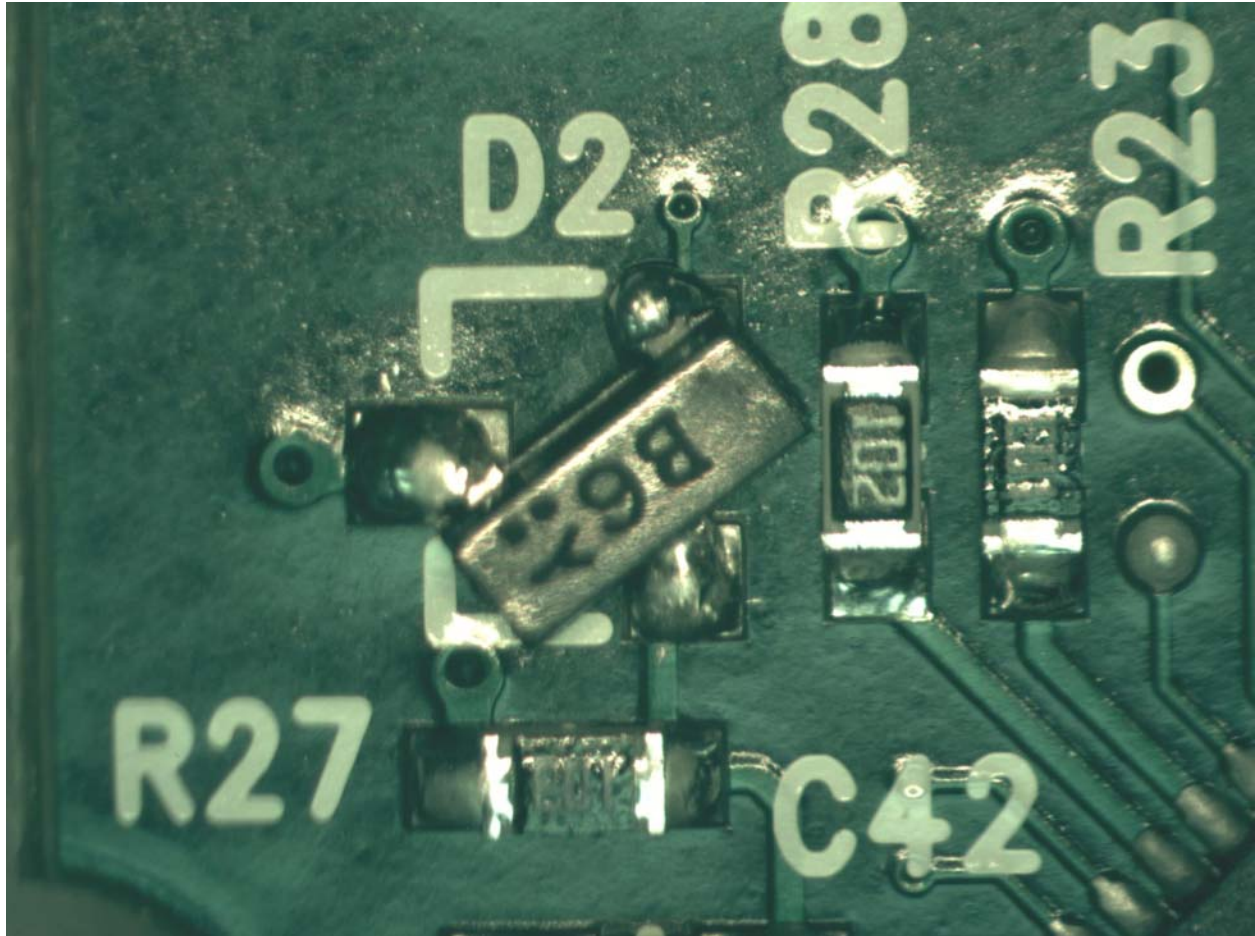
The Ethernet PHY was intermittent and would powerup at different addresses. It was determined that the reset circuit was not functioning properly due to improper footprint for D2.

1. Rotate D2 diode 120 degrees counter-clockwise

Reason for change: 1. Correction for incorrect SOT23 footprint of D2		Disposition/Effectively	
		Use as is	
		Rework to ECO	X
		Scrap & Rebuild	
		Record Change Only	
Prepared by:	M. Hall	Date:	03/27/09
Approved by:		Date:	
Approved by:		Date:	
Approved by:		Date:
