FDI	ENGINEERING CHANGE ORDER		ECO NO: 09-005b
			Page 1 of 2
TITLE	DWG NO.	CURRENT REV	NEW REV
ARM9DIMM LP3250	ARM9DIMM	1.0	1.1

FDI	ENGINEERING CHANGE ORDER		ECO NO: 09-010
			Page 1 of 1
TITLE	DWG NO.	CURRENT REV	NEW REV
ARM9DIMM LP3250	ARM9DIMM	1.1	1.2

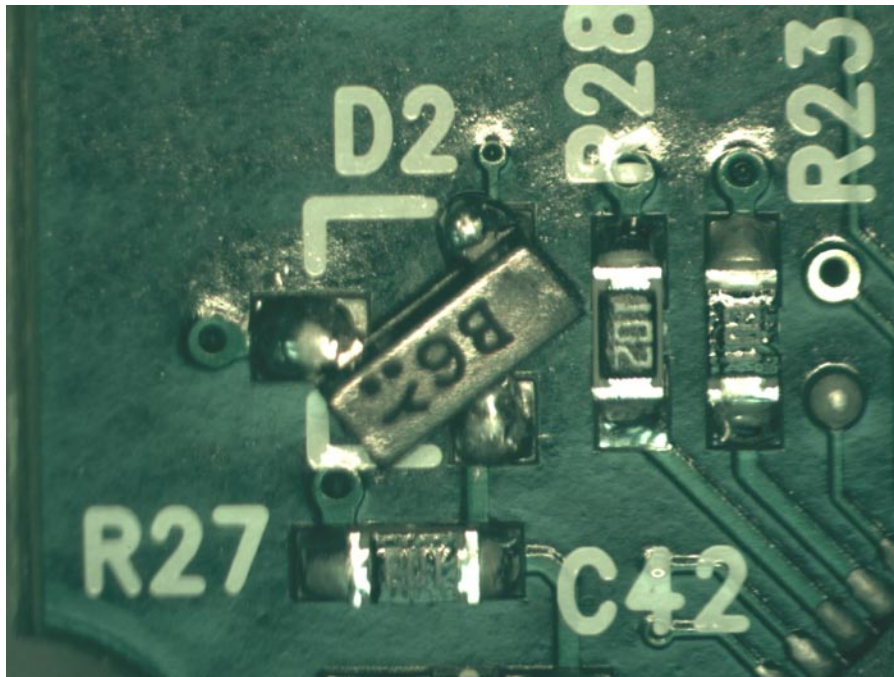
- The Ethernet PHY is intermittent and would powerup at different addresses. It was determined that the reset circuit was not functioning properly due to improper footprint for D2.
- The CPU core voltage needs to be increased to 1.35V in order to support 266MHz.
- The Wall Power Detect needs to be disconnected from the LPC3250 to allow the touch screen to function properly.
- The Seggar JTAG Debugger utilizes a IDC 10-pin 2mm ribbon connector that will not work with the original shrouded connector
- The Debug Connector is required for initial programming

1. Rotate D2 diode 120 degrees counter-clockwise
