FDI	ENGINEERING CHANGE ORDER			ECO NO: 17-035	
				Page 1 of 4	
TITLE	ASSY PN	CURRENT REV	NEW ASSY PN	NEW REV	
uEZGUI-4088-43WQN	AUG4043QNBA14	1.4	AUG4043QNBA2	2.0	
uEZGUI-4088-43WQN	AUG4043QN13	1.3	AUG4043QN2	2.0	
uEZGUI-4088-43WQH	AUG4043QHBA13	1.3	AUG4043QHBA2	2.0	
uEZGUI-4088-43WQH	AUG4043QH13	1.3	AUG4043QH2	2.0	
uEZGUI-4088-43WQE	AUG4043QEBA13	1.3	AUG4043QEBA2	2.0	
uEZGUI-4088-43WQE	AUG4043QE13	1.3	AUG4043QE2	2.0

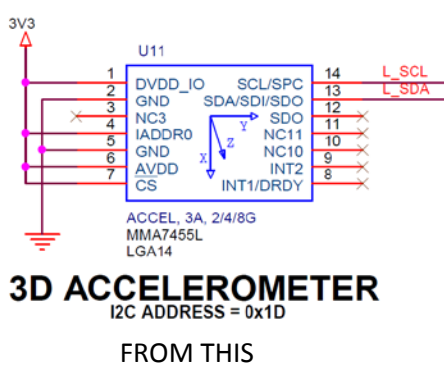
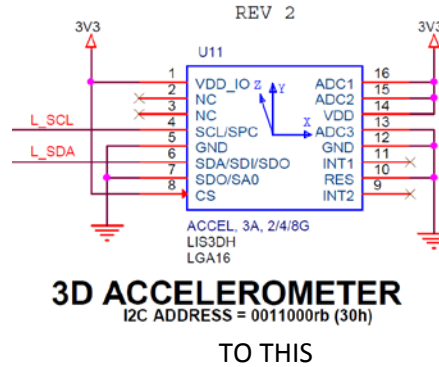
1. Change U11 from MMA7455L, FDI PN: U500437 to LIS3DH, FDI PN: U500639

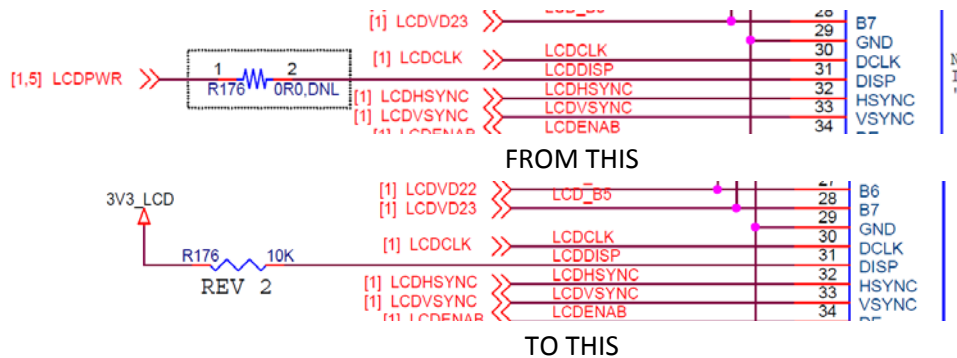
- Change R176 from series connection to MCU, to pullup to 3.3V and change value from zero ohm (DNL), FDI PN: R500436 to 10K (Loaded), FDI PN: R500029

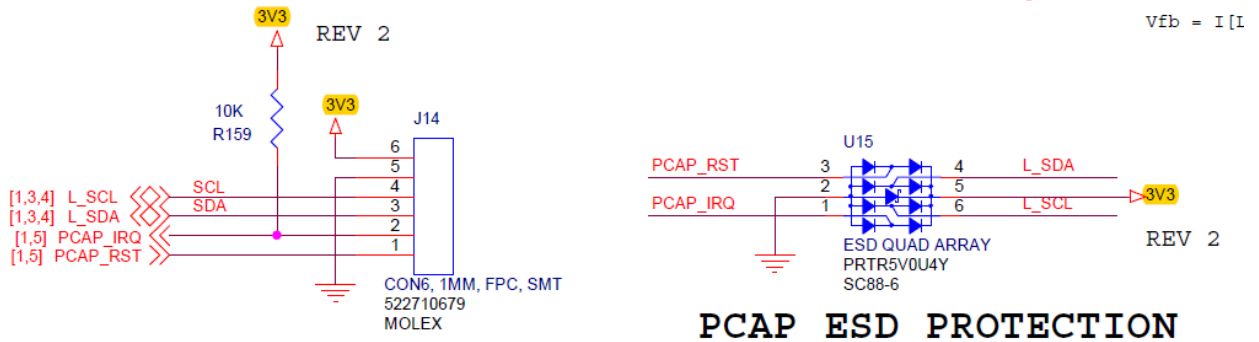
- Change LCD PCAP connector, pullup, and ESD protection from switched 3V3_LCD to non-switched 3V3, highlighted below; (no component changes)

NOTE: PINOUT OF PCAP FPC TAIL IS REVERSED FROM PINOUT OF MOLEX CONNECTOR

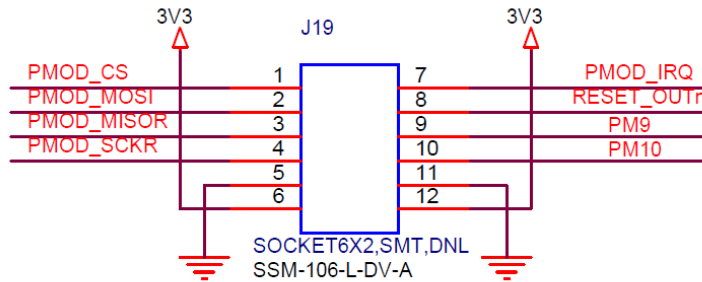
OPTIONAL STRAIGHT SMT
REV 2

4. Add optional vertical PMOD socket (J19) for customers that require vertical mounting of PMOD;

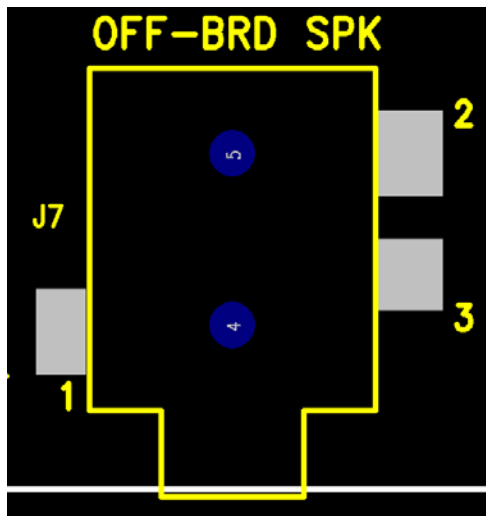
FROM THIS

5. Change audio jack (J7) PCB footprint to support current vendor (RDI)

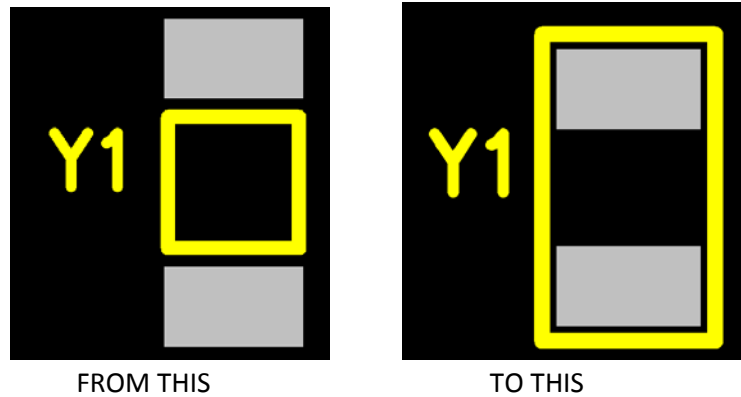
6. Change 32.768Khz crystal (Y1) PCB footprint to match current vendor for FDI PN: X500027
